**SAS Superstructure**

**Daily Diary Report by Bid Item**

Contract No.: 04-0120F4

Diary #: 883 Const Calendar Day: 416 Date: 25-Jul-2013 Thursday

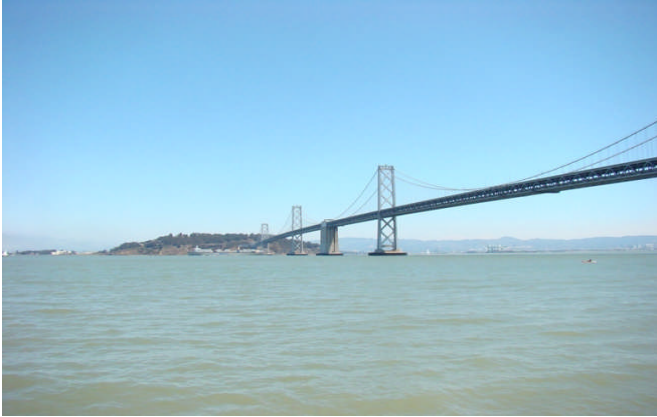
View from control point SFOBB2 set by District 4 surveyor Khin Voong for the West span SFOBB traverse.

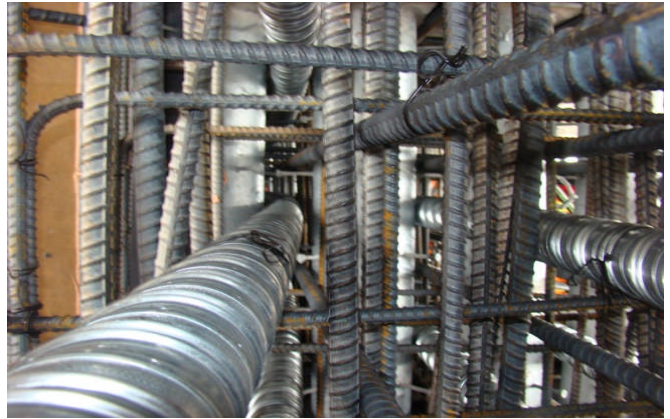
Flexi-duct placement of S1 Shear Key retrofit transverse tendon B3T5 South done late yesterday looking east.

- Completed installation of the flexi-duct for transverse tendons B3T1-6 on both the north and south ends of the S1 Shear Key retrofit. Ron assisted Harris Salinas ironworkers with rebar placement today and also continued to prepare for extra strong pipe placement and duct placement for vertical, draped, and bottom longitudinal tendons for the S1 Shear Key retrofit.

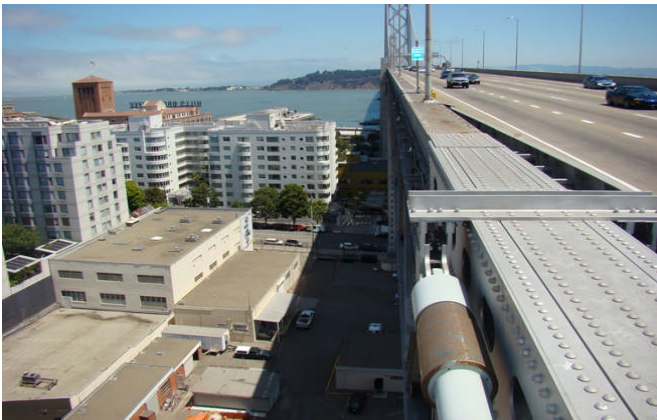
View from the West span SFOBB anchorage where the primary control on the Embarcadero will be used to set traverse points, photo is looking east.

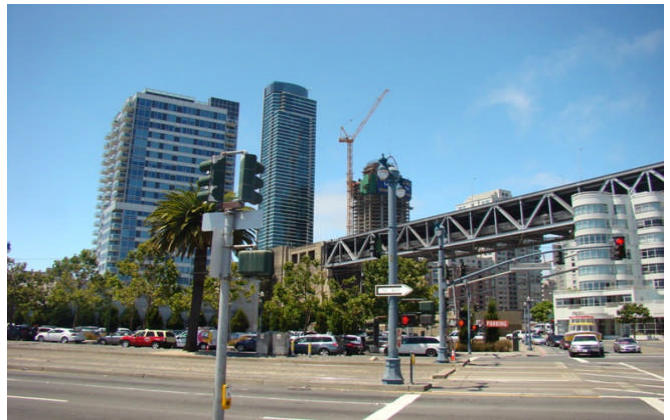
View from control point SFOBB1 set by District 4 surveyor Khin Voong for GPS recon work prior to Static GPS calibration for the entire SFOBB.

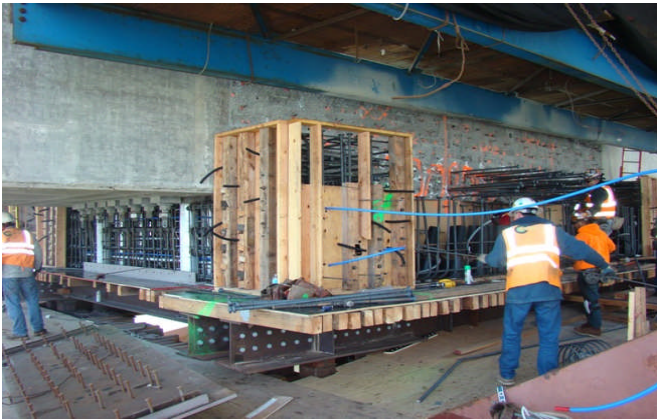
Conco carpenters placing water cooling pipes along the north side of the soffit beam for the S1 Shear Key retrofit.

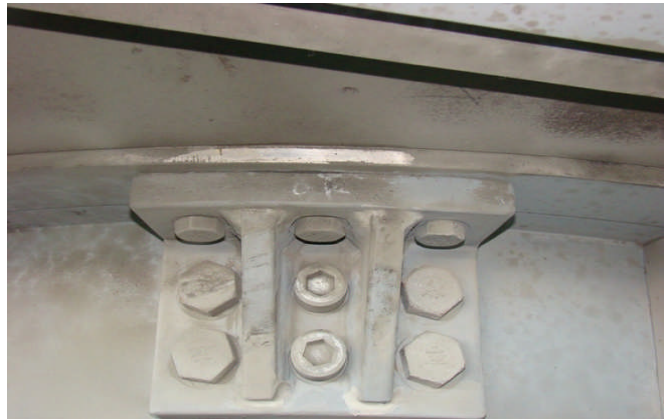
Dust or debris seen after CCC sand blasted and painted the S1 Shear Key lower base section.
